**REPORT ON THE MISHAP
OF THE AIRCRAFT SOCATA TB21 TRINIDAD
REGISTERED PH-UBG AT NEEROETEREN
(BELGIUM) ON 10 APRIL 2001**

**CELLULE D'ENQUETES
D'ACCIDENTS
ET D'INCIDENT D'AVIATION**

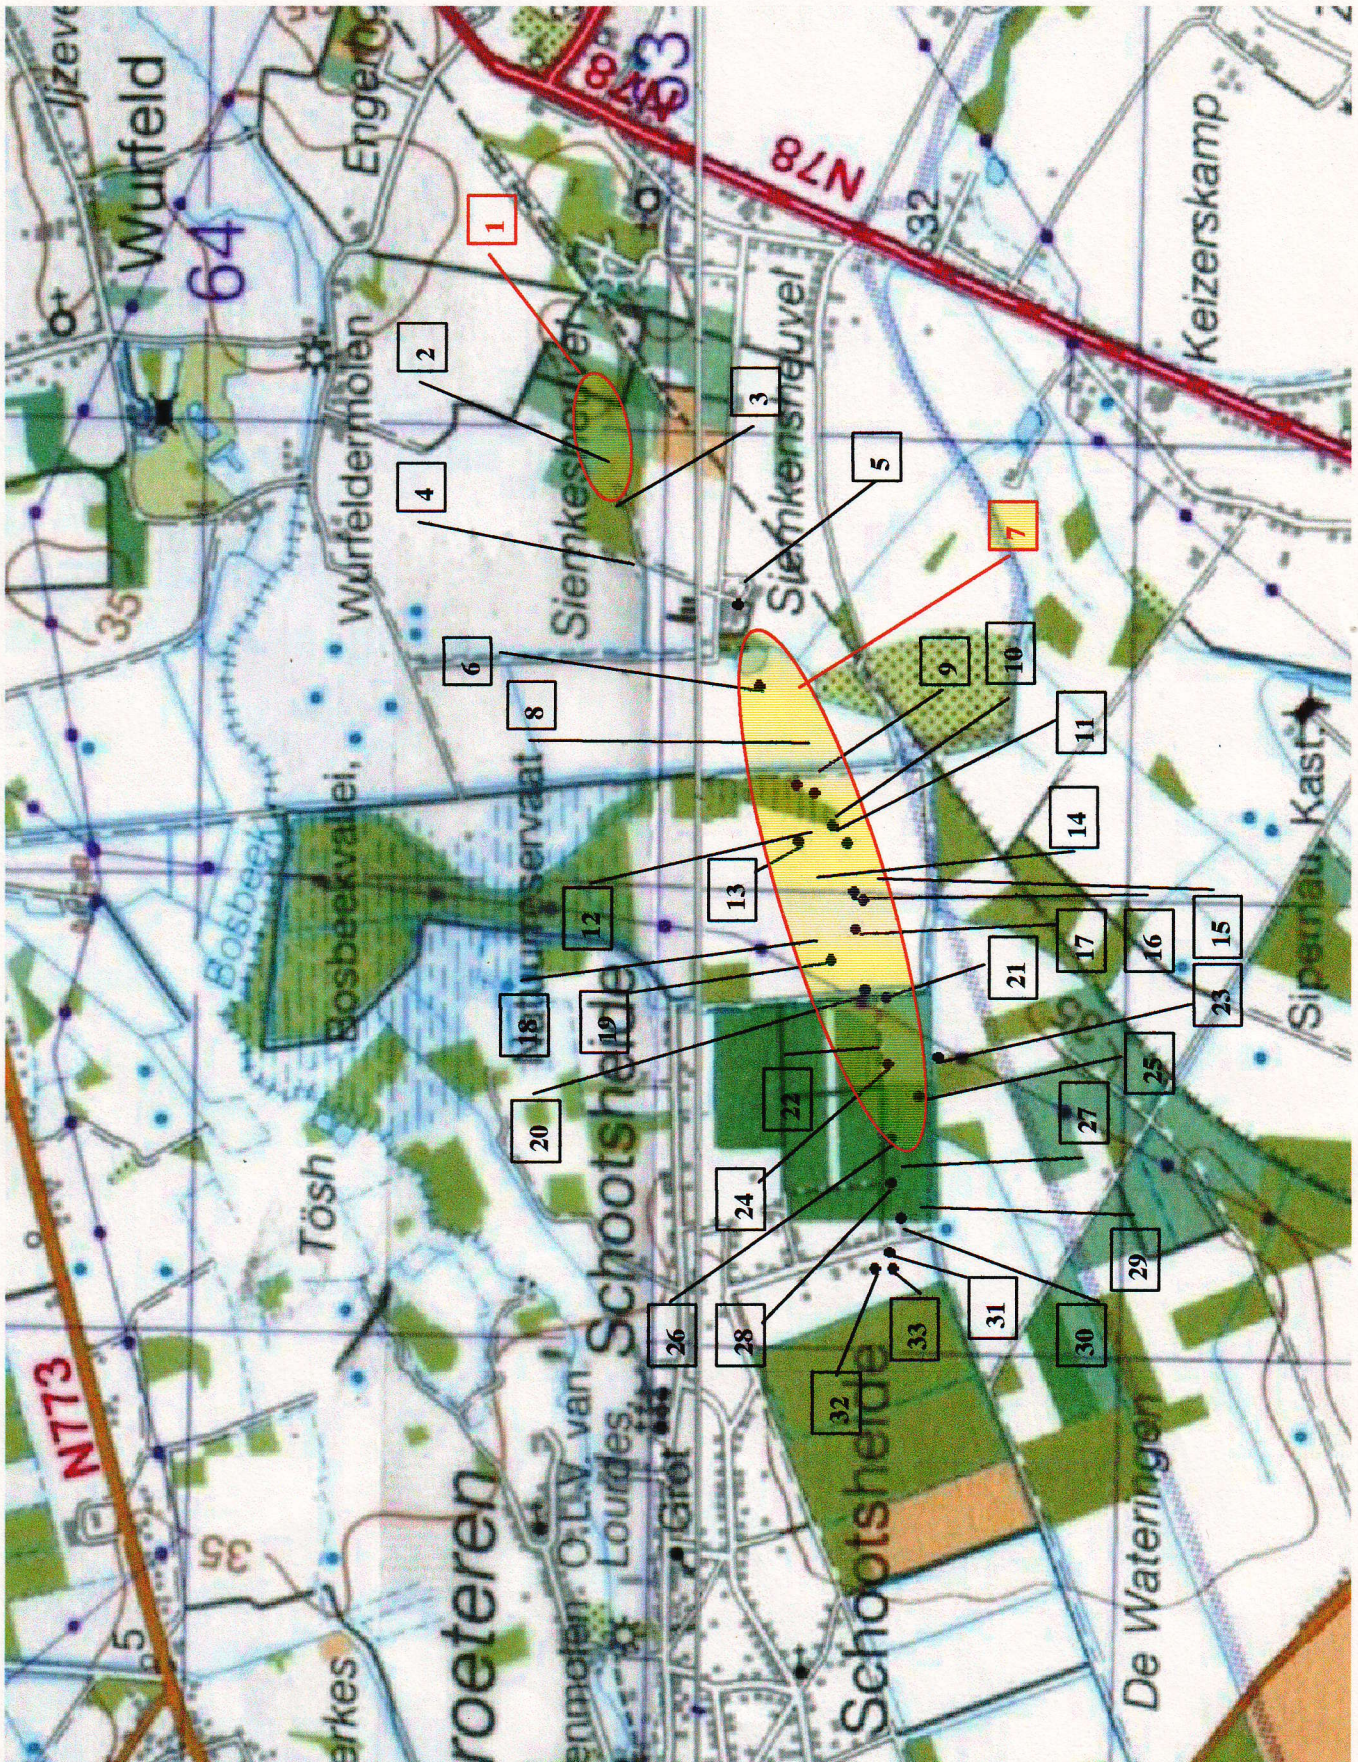
Map of the site.

The PH-UBG is disintegrated and the parts are spread on a little bit more than 2km across woods and fields southeast of NEEROETEREN. The general direction of the site is 065-245. Starting from the eastern side of the site and following the trajectory, the first pieces found are coming from the cabin (insulation material, plastic from the interior fittings, pieces of the canopy/windshield, papers,...) and from the wings (pieces of skin plates, pieces of ribs, pieces of wingtips,...), mainly the right one. Photos 01 and 02 show some of these pieces. Then comes a part of the right flap (Ref 19 and photo 03) and the right aileron (Ref 21). Close to them along a small road, a dead goose has been found (Ref 20 and photo 04). In the woods, the pieces are becoming bigger when approaching the main part of the wreckage: horizontal tail (Ref 23 and picture 05), rear seat (Ref 24), part of the canopy frame (Ref 24), left aileron (Ref 24), amongst other smaller fragments (pieces of flight control rods, ribs, sheared plates,...pictures 06 and 07). The right wing (Ref 30 and photo 08) is at the edge of the wood alongside a garden. The fuselage and the left wing (Ref 31, picture 09), both inverted, are in a meadow 70m away from there. There is only one rather deep crater under the fuselage, which indicates that it did not rebound. There is no indication that it skidded on the ground. The bodies of both occupants (Ref 32 and 33) are respectively 40 and 50m from the fuselage. They made an impact approximately 20cm deep in the rather soft soil before rebounding a few meters.

The repartition of the parts on the ground shows that the disintegration started with the right wing. Quite a lot of parts of it (plates, ribs, wheel bay) were found in the first hundreds of meters of the site. The left wing started disintegrating very soon after the right one as shown by the position of the first plate of it (annex 1, page 1, Ref 6). It is important to realize that the first parts of the wings found are coming from the wingtips, which is typical of disintegration caused by exceeding the ultimate load factor (ULF).

In the mean time, the cockpit started disintegrating. Very soon cabin insulation material (annex 1, page 1, Ref 1), documents usually found in the cabin (weather charts, parts of the aircraft flight log found at the place referenced 5 at the map at annex 1, page 1). These elements were blown by the wind in the direction of the beginning of the site. At short distance from there, one begins finding the first pieces of windshield and canopy perspex.

The wings went on disintegrating, the right one more than the left one as shown by the repartition of the fragments. The right flap then sheared off. The external part of it separated from the wing. Almost immediately after that, both ailerons detached from the wings, first the right then the left one, the latter found approximately at the same height as the horizontal tail that separated from the fuselage as well. In fact, the complete rear cone of the fuselage where the horizontal tail is attached failed and separated in flight. This is also typical of exceeding the ULF. Many parts coming from the cabin (roof, sides, doors, rear seat, interior fittings) are found between the place where the horizontal tail was found and the fuselage. The failure of the main wing spar caused the complete destruction of the cabin, both wings being bent upwards. Both occupants have most probably been ejected at that moment or very soon after. The separation of the horizontal tail causes a violent pitch down of the aircraft and the external attaching points of the harnesses stayed with the sides of the cabin that remained with the wings.
